# Biological Complications of Dental Implant

## **Biological Complications** affect the tissues supporting the implant and prosthesis.

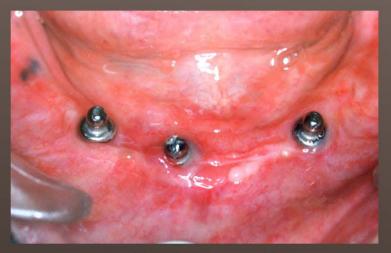
Peri-implant mucositis

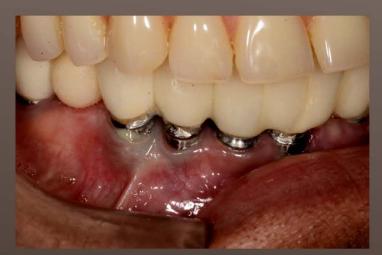
Peri-implantitis

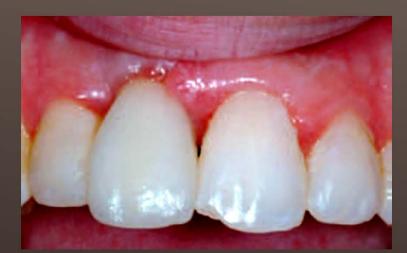
Is a reversible inflammatory lesion, similar to gingivitis, affecting the marginal soft tissues surrounding Osseo-integrated dental implants and is not associated with peri-implant bone loss.

Peri-implant mucositis associated with implant retained crown UR1

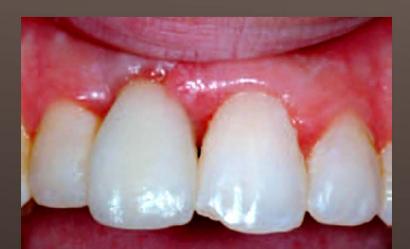
Peri-implant mucositis may affect up to 50% of implants and is characterized by bleeding on probing.

Peri-implant mucositis associated with implant retained crown UR1

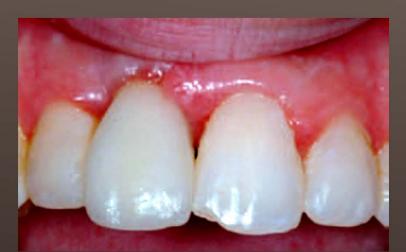
Peri-implant mucositis usually resolves with improved homecare, antiseptic mouthwash and careful mechanical cleaning.

Peri-implant mucositis associated with implant retained crown UR1

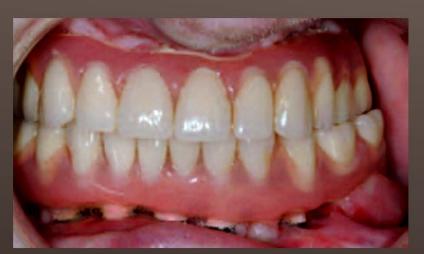
Hyperplasia of the peri-implant tissues represents an over-exaggerated response to plaque accumulation and may be associated with poor oral hygiene, framework misfit, dead space beneath frameworks and a lack of attached gingivae.

Hyperplasia of the peri-implant soft tissues associated with the distal aspect of an ill-fitting lower implant retained bridge

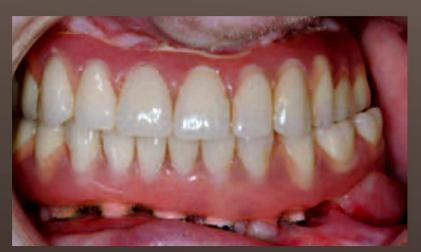
Hyperplasia usually resolves following correction of predisposing factors, improved oral hygiene and mechanical debridement. However, it may occasionally be necessary to surgically resect the hyperplastic tissue.

Hyperplasia of the peri-implant soft tissues associated with the distal aspect of an ill-fitting lower implant retained bridge

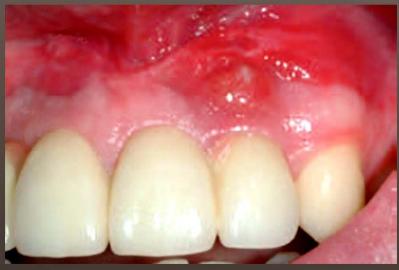
Fistulae have been reported at the level of the implant-abutment interface and they are usually associated with loose abutments screws or ill-fitting frameworks.

Fistula associated with a loose abutment screw UL2

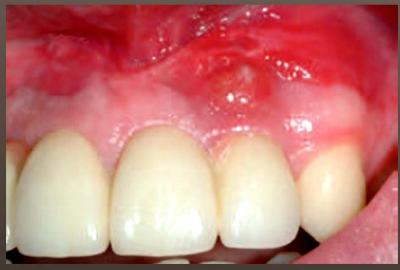
These fistulae usually resolve following removal of the prosthesis, irrigation with 0.2% chlorhexidine gluconate (Corsodyl, GlaxoSmithKline) and replacement of the prosthesis at the correct torque.

Fistula associated with a loose abutment screw UL2
